# Illicit Discharge Detection and Elimination

City of Denton – January, 2020

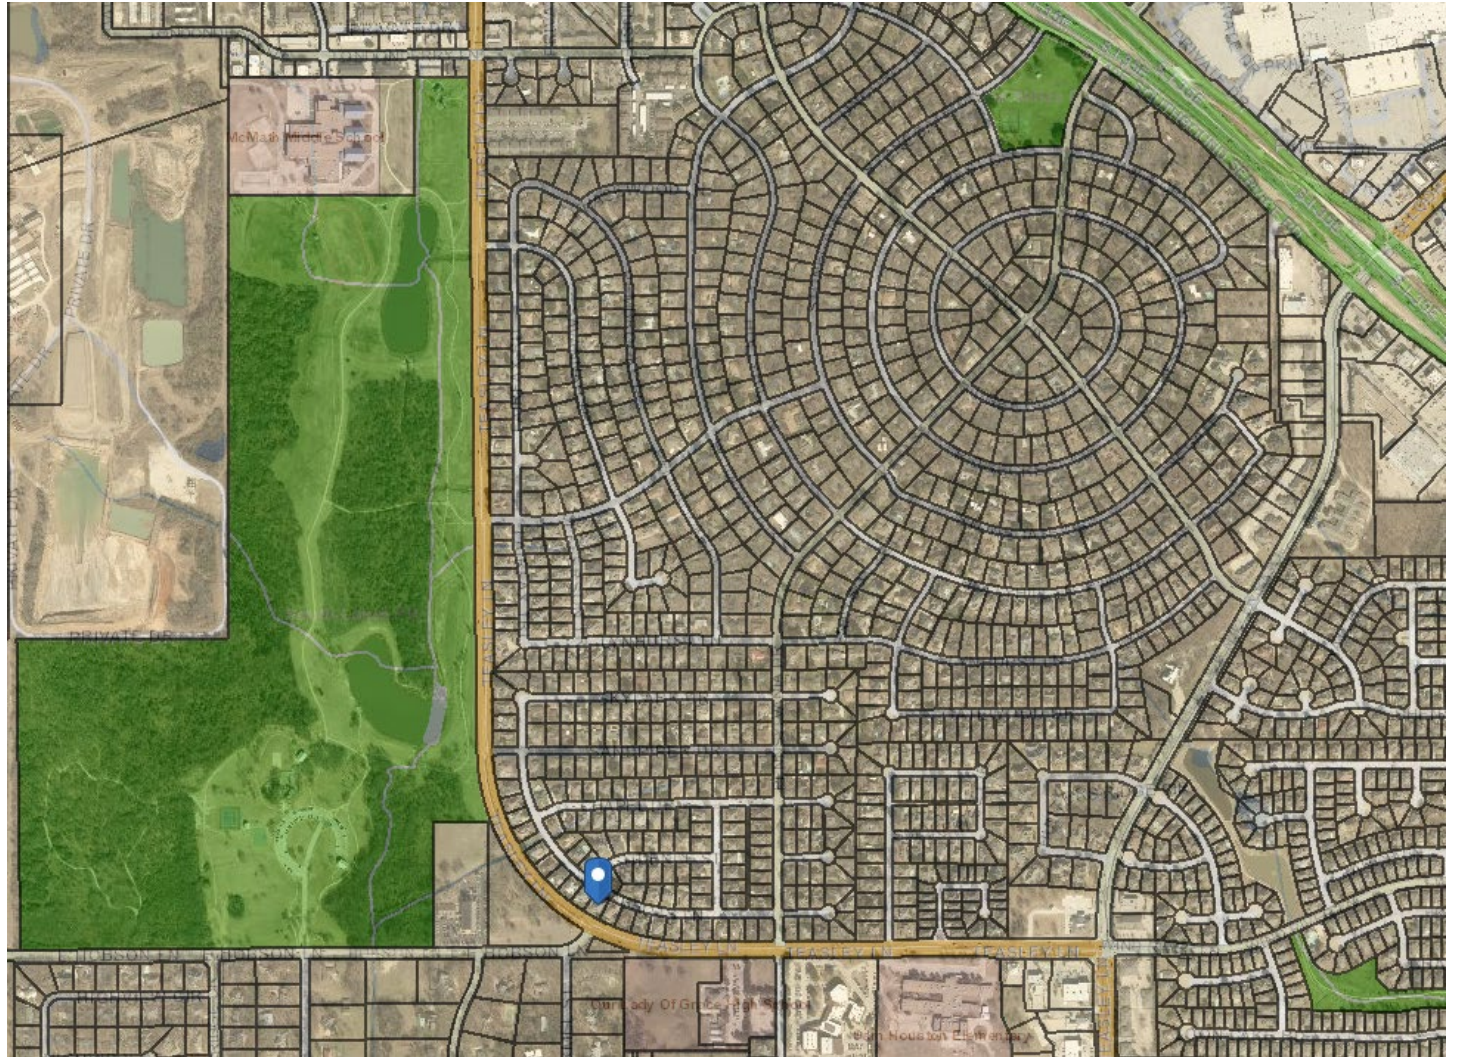
- Received complaint from citizen January 2020
- Bubbling in storm sewer, sewage smell
- Storm sewer draining from residential area
- Daylights at culvert under road

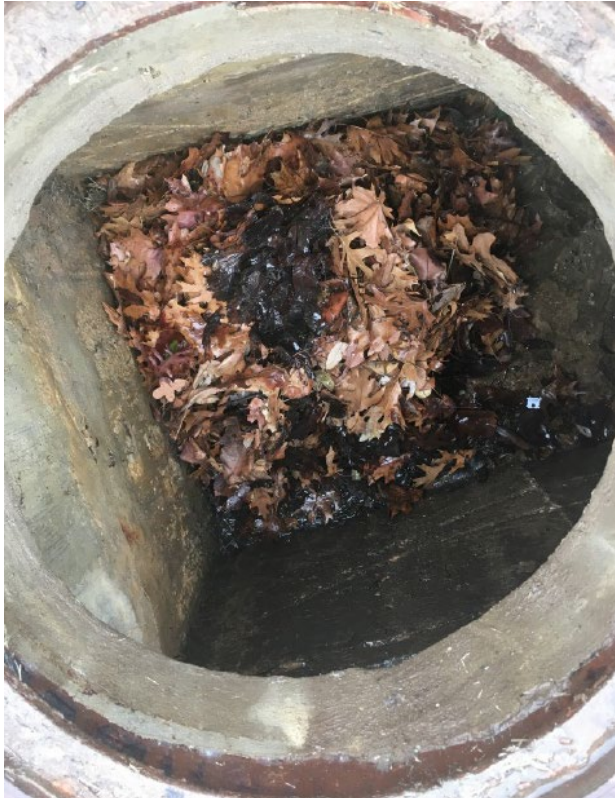
- Pulled manhole covers

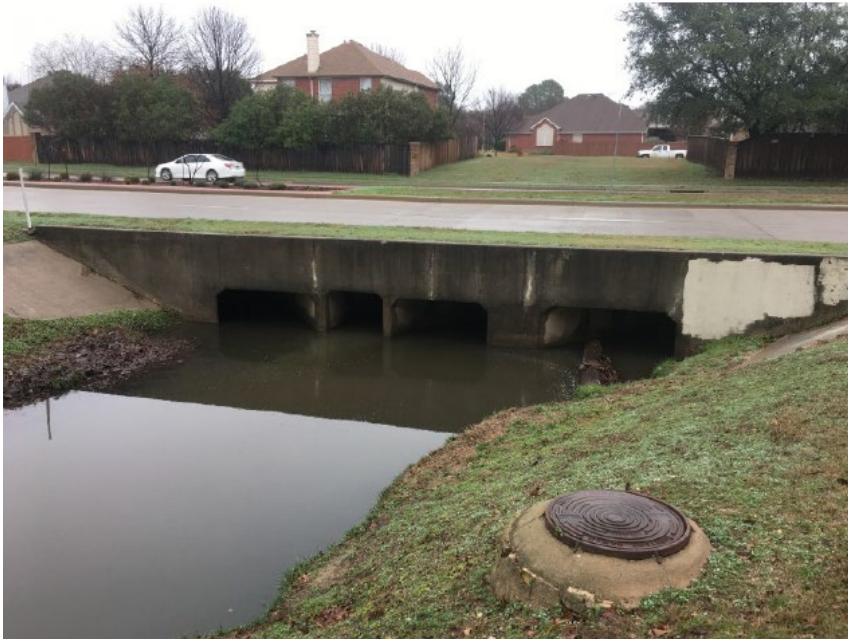
- Inspected outfall where daylights

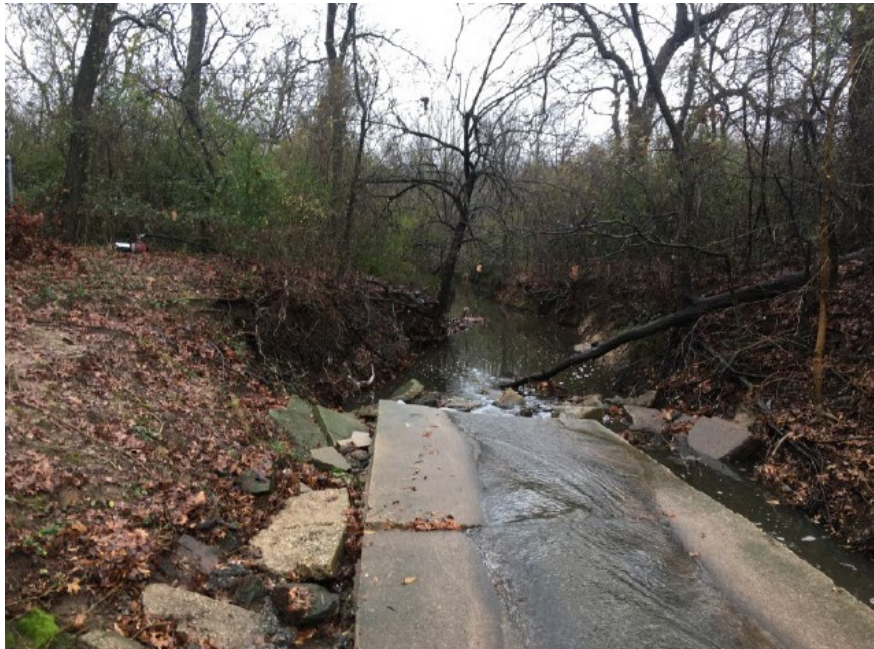
- Inspected end of concrete flume

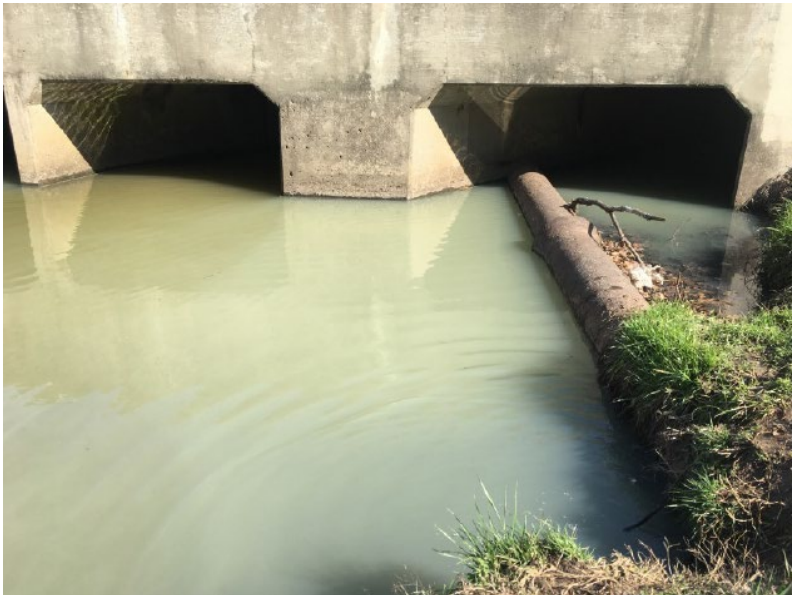
- Resampled next week
- White precipitate/turbidity
- Strong odor of sulfur

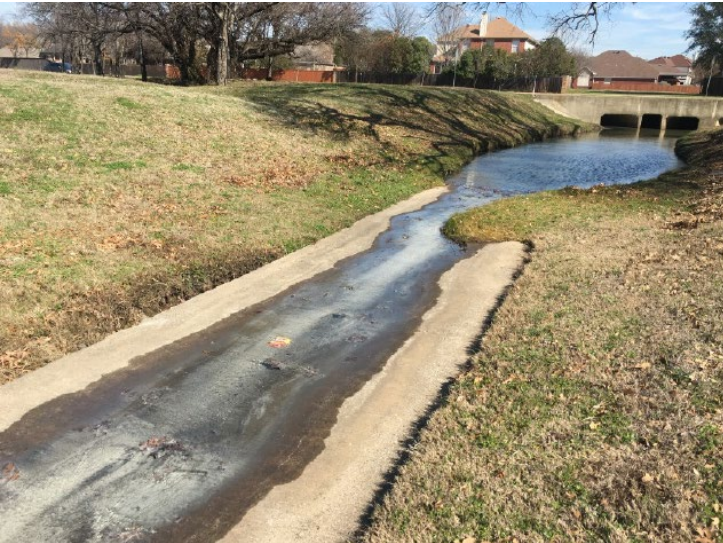
- Resampled next week
- White precipitate/turbidity
- Strong odor of sulfur

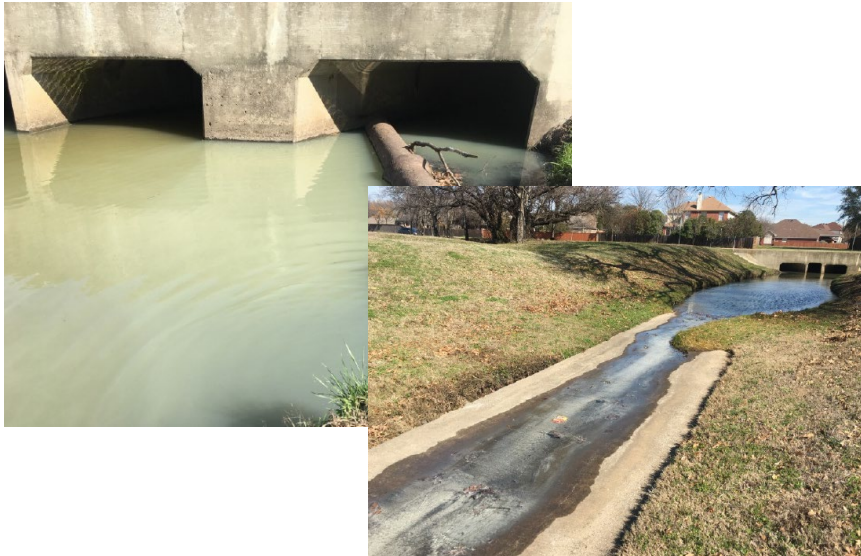
- Collected samples
- Moderately high Cond, E Coli, Ammonia, BOD.
- No significant metals indicated

- Reached out to wastewater collections/engineering to perform smoke test to check for sanitary sewer leak. Awaiting.
- Other ideas/suggestions?
