# Applications of bacterial source tracking data in the San Antonio River Basin

Friday, April 1, 2022

# San Antonio River Watershed

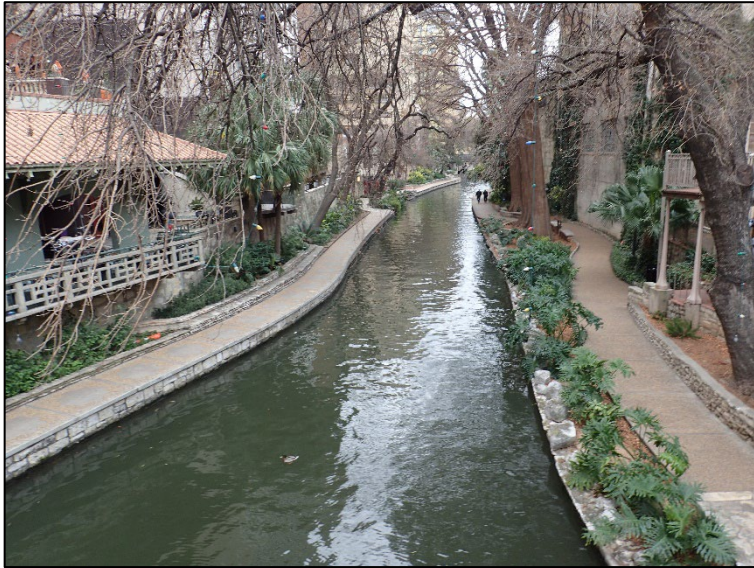
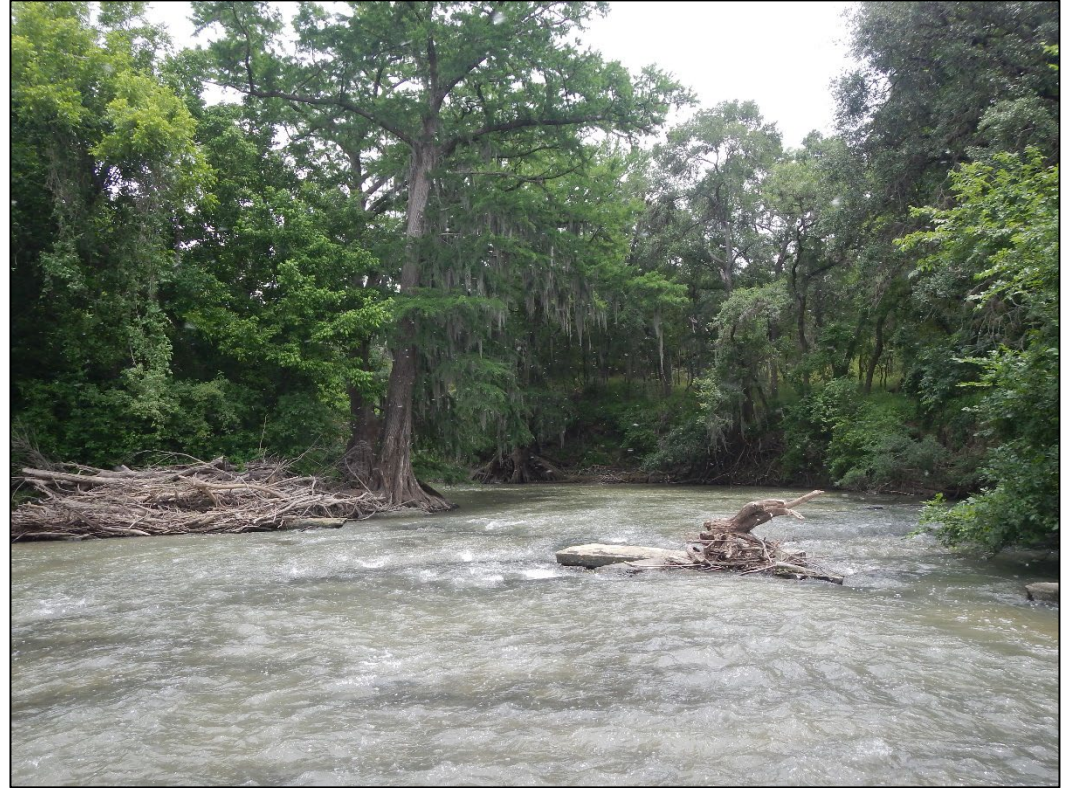
- Drains ~4,180 mi.<sup>2</sup>
- Main stem ~240 mi.
- 13 classified segments
